# Nº 166 Service Bulletin

**DATE:** September 20, 2006

**SUBJ:** Grand Prix / NASCAR®  
Trough Up-Kicker Failure

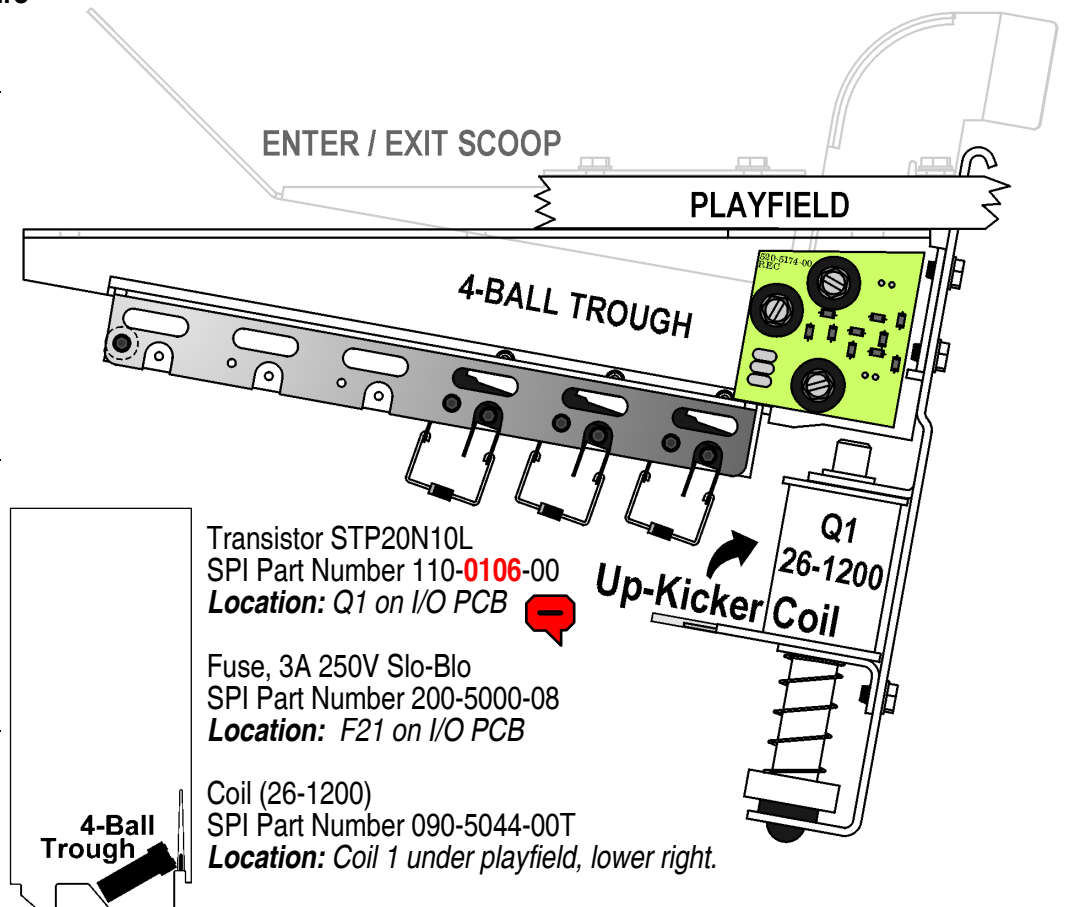
- Game will not start.
- 50VDC coils are inoperable.
- I/O Power Driver PCB F21 3A 250V SLO-BLO Fuse is blown.
- Trough Up-Kicker (*Coil #1*) is overheating (*paper wrap is browned*).
- **Q1** Transistor STP20N10L (*on I/O PCB*) is shorted.

The Game Software Version **4.20** or lower (*U210 on the CPU/Sound Board II*) has a problem in which it may repetitively fire the Trough Up-Kicker Coil when serving the ball up to the *Shooter Lane*.

**Ensure your Game Code** on your CPU/Sound Board in location U210 is **v4.50+** and replace all faulty components.

If you do not have an ePROM Burner, you'll need to order the latest version on an EPROM from your local distributor. Ask for SPI Part Number 960-5009-00 and specify if you need Grand Prix or NASCAR Game Code.

For the location & how to change out your EPROM (**U210**), refer to Service Bulletin **150**. Also, review Service Bulletin **161, Part 1: Enter/Exit Scoop Modification**, to ensure you have the proper length screws for the Enter/Exit Scoop.
