Ghostbusters Flasher #129

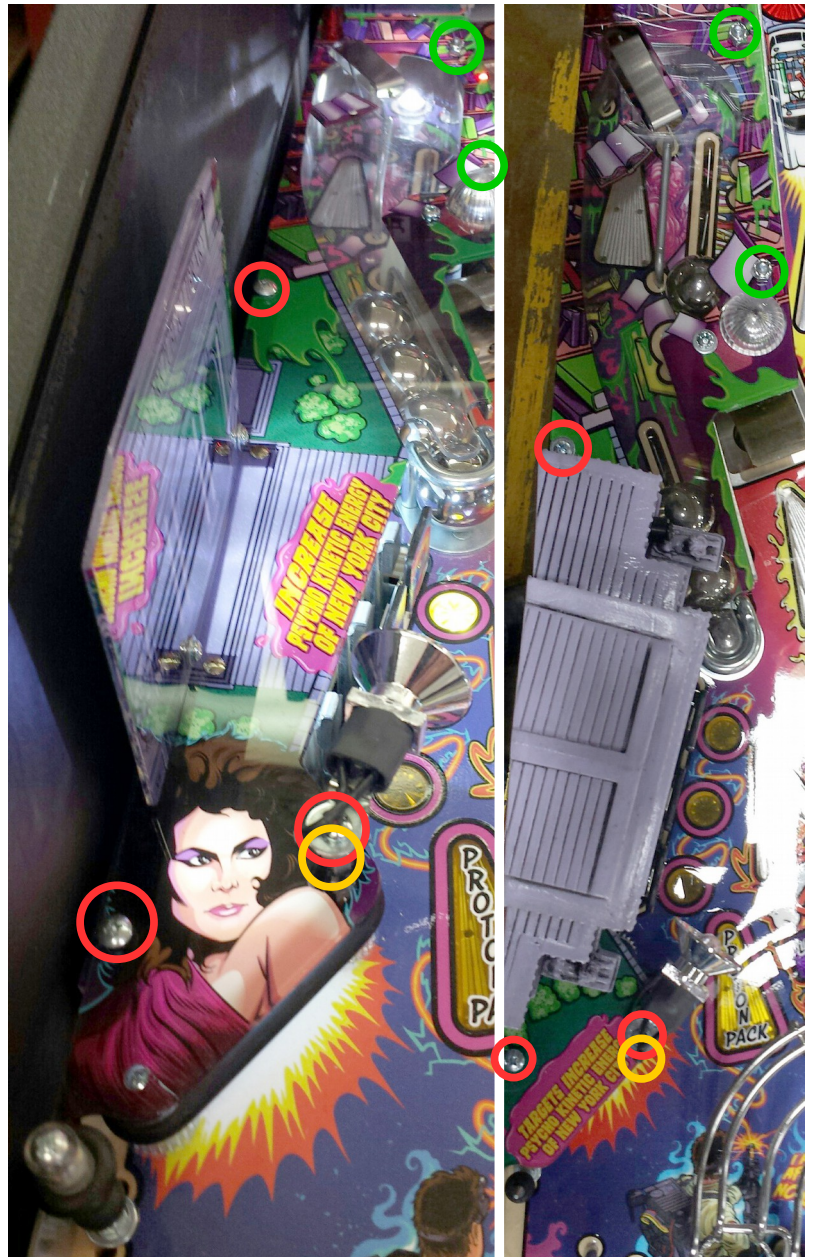
Remove the hardware listed securing Plastic #05

3 - Phillipshead Screws

2 - 5/16" Nuts

1 - 1/4" Hex Spacer

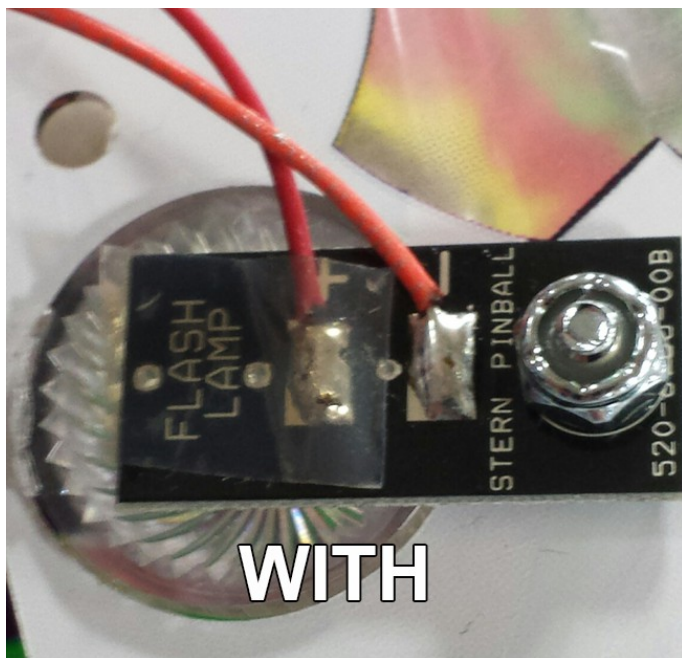
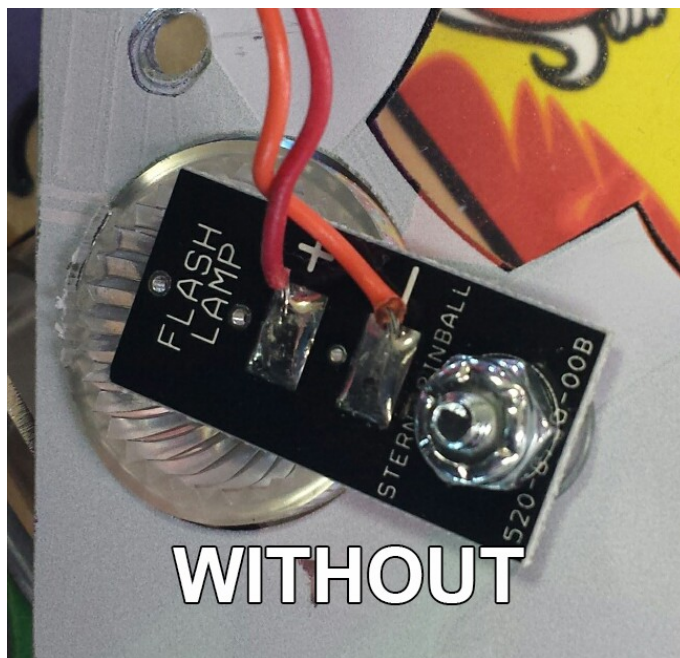
The +5 volt source supplying the "Left Scoop" Flasher #129 intermittently shorts to the metal ball guide rail located underneath it.

Flip Plastic #05 over in order to inspect the LED flasher PCB. The LED flasher PCB should have a non-conductive Mylar strip or fiche paper protecting the backside of the board.

Insulate the "Left Scoop" Flasher PCB with a non-conductive strip.

If your LED flasher is missing the protective Mylar or fiche paper, contact Stern Pinball Inc. at 1-800-KICKERS or Parts.Service@sternpinball.com to receive service kit 502-7033-00.
