Nº 149 SERVICE BULLETIN

SUBJ: Potential Ball Trap by the Upper Left Pop Bumper (ask your Distributor for SPI Kit Nr. 502-5025-81)

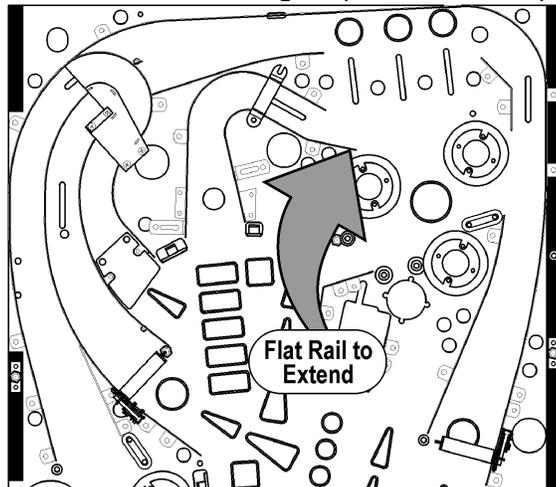
Figure 1

A Pinball gets trapped behind/under the **Upper Left Pop Bumper Cap** (next to Plastic Ramp). See Fig. 1 below.

Get the Flat Rail (Ball Guide) Extension Installation SPI Kit, 502-5025-81 and install the Flat Rail (Ball Guide) Extension, 535-9468-00 (see Fig. B, next page). This kit includes a detailed step-by-step procedure with photos, a copy of this Service Bulletin and the new Add-On Extension Flat Rail and Securing Hardware.

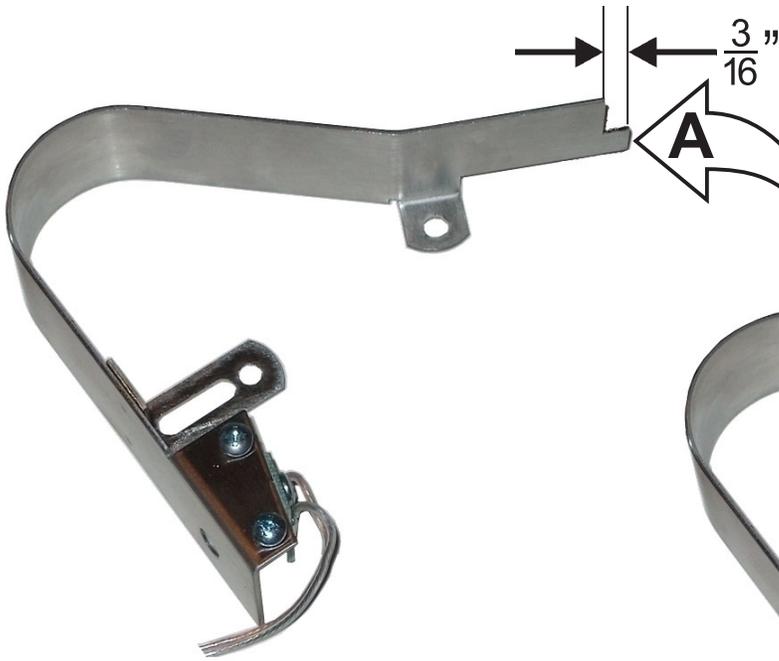
Early production games had a Flat Rail, 535-9327-00 (Item 35, Page 64 of your Ripley's Service Game Manual) which did not extend out far enough to prevent a ball trap; if the extension measures approximately **3/8"**, **this fix is not required** (see Fig. C & D, next page). The next page depicts the old, modified and new rails so you can determine if your game requires this installation. **ONLY** Games with the extension measuring approximately **3/16"** would require this fix (see Fig. A, next page).

**ORIGINAL FLAT RAIL
REQUIRING ADD-ON
RAIL FIX ∴ 3/16" to 3/8"**

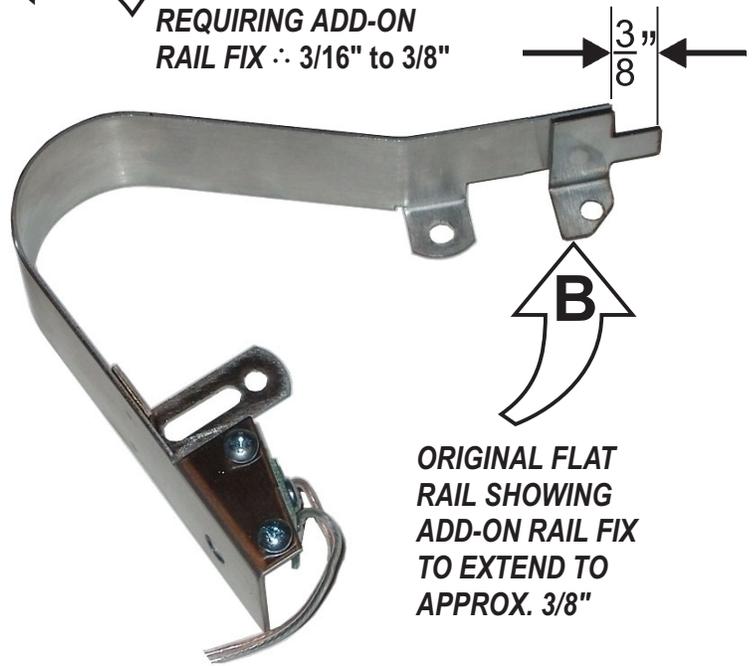
**ORIGINAL FLAT
RAIL SHOWING
ADD-ON RAIL FIX
TO EXTEND TO
APPROX. 3/8"**

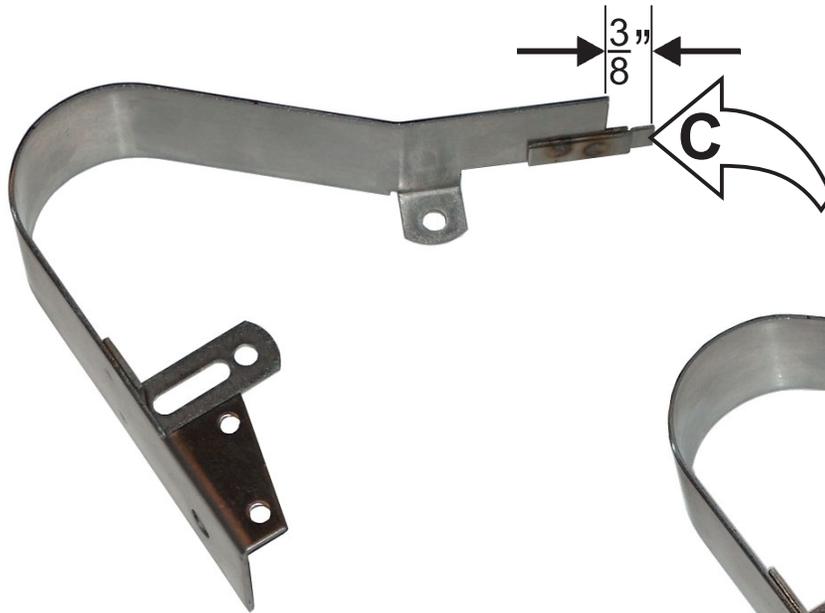
**FLAT RAIL WITH A
WELDED EXTENSION
(DOES NOT REQUIRE
THE ADD-ON EXTENSION)**

IF YOUR FLAT RAIL (535-9327-00, Item 35, Page 64 of your Game Manual) looks like either of the bottom examples (C or D), you do not require the Add-On Extension Rail Fix. Note the extended tab length (by Pop Bumper Ring) should be approximately 3/8" long.

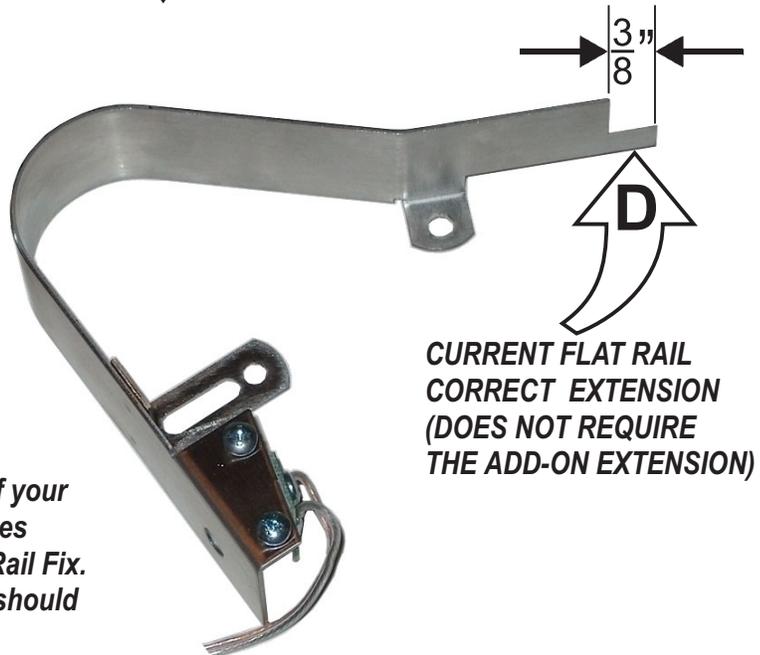
**CURRENT FLAT RAIL
CORRECT EXTENSION
(DOES NOT REQUIRE
THE ADD-ON EXTENSION)**
