TO : Parts & Service Managers    DATE : December 27, 2006

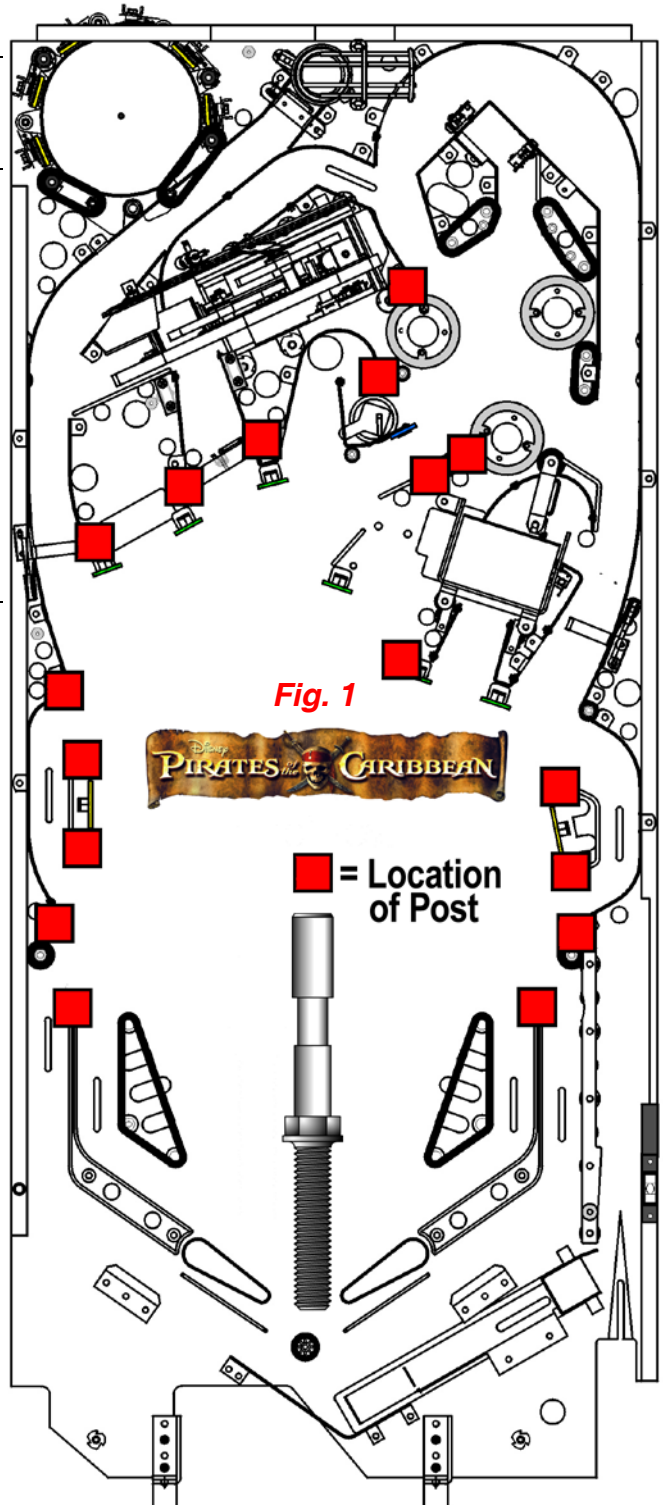
One or more playfield posts have become loose (see **Fig. 1**). After retightening the posts, they work loose again.

We have seen the 3/8" Nylon Stop Nut (#10-32), that secure 17 posts on the playfield (**Fig. 1**), become loose on some machines. This is caused by the nut not having enough thread to grab on the post due to normal variances in playfield thickness, washer thickness and post thread length.

**PLEASE NOTE: >>> NOT ALL POSTS ARE AFFECTED <<< HOWEVER, FIND ALL OF THE POSTS UNDER THE PLAYFIELD USING THE LOCATION MAP (FIG. 1) AND RETIGHTEN WITH A 3/8" NUT DRIVER. INSPECT THE NUTS TO ENSURE YOU SEE 1-2 THREADS THROUGH THE NUT; IF NOT, PERFORM SOLUTION BELOW.**
