Troubleshooting:

Motor does not turn or energize:

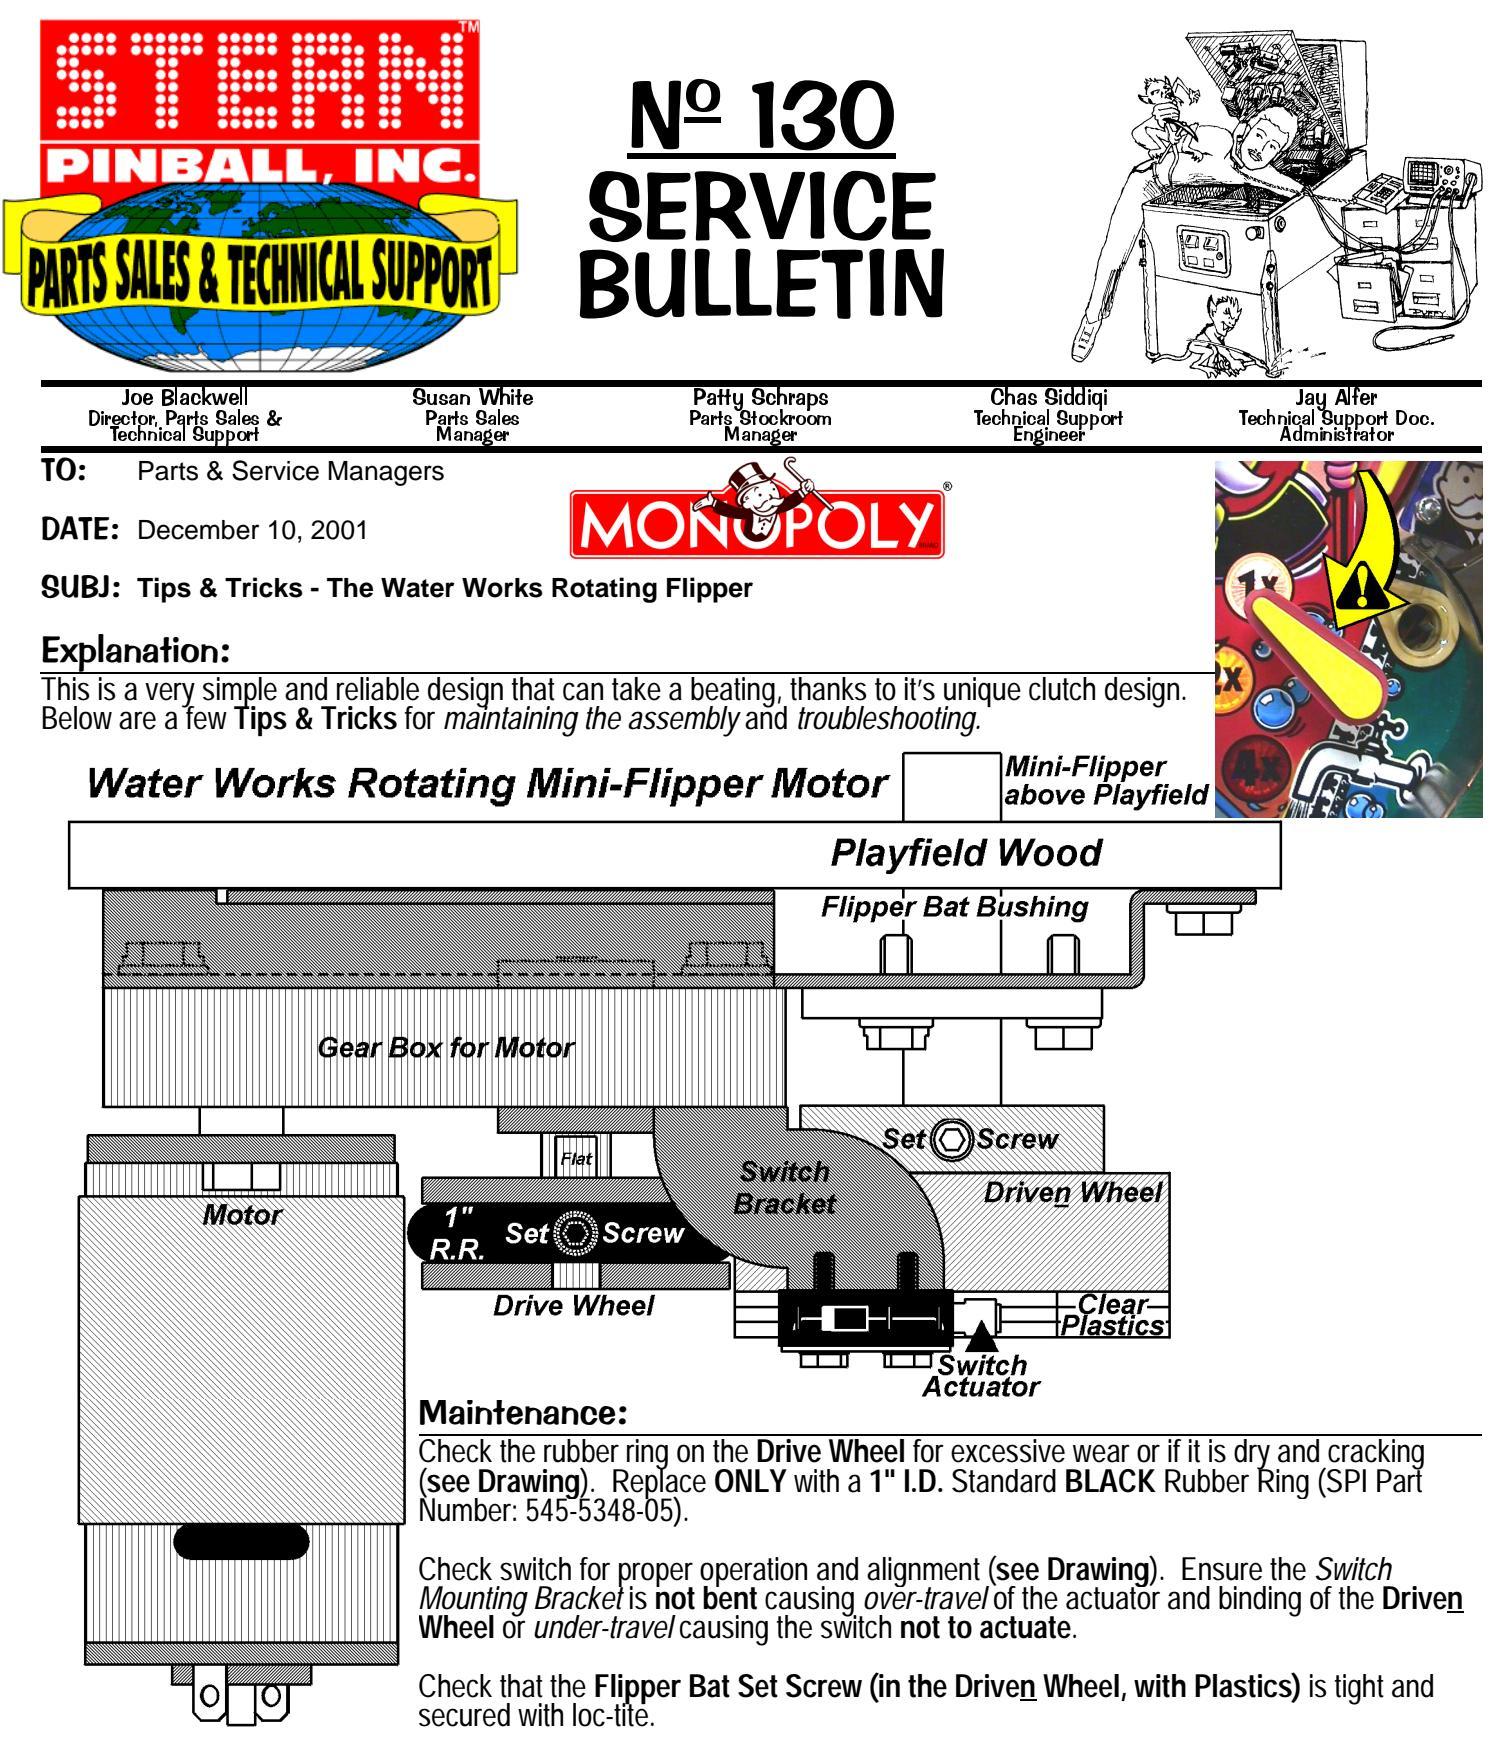
The flipper is moving but cannot get the ball out of the hole:

1. Ensure the **Set Screw** on the **Driven Wheel** for the **Flipper Bat** is tight and aligned *with the flat* on the **Flipper Bat Shaft**. Make sure the **Flipper** is as tight to the playfield as it can be without binding. If it has a lot of upward movement, it can ride up the side of the ball and force it down. *Ensure the Flipper Bat Red Rubber Ring is seated properly; it is possible the rubber ring may have slid up the flipper bat and have a similar effect.*

2. Check that the **Rubber Ring** on the **Drive Wheel** is a **1" I.D. Black Rubber Ring** and *not smaller* (the size is printed on the side with raised lettering). By design, this rubber ring appears to be oversized and fits somewhat loosely, this is correct. *Note: Do not replace with a 1" I.D. White Rubber Ring as the material differs slightly and operation could be affected.*

Check all fasteners to ensure they are tight (**DO NOT** over-tighten the **Motor Gearbox Screws** as this may cause binding of the gears). Note: Don't forget the Set Screw in the Drive Wheel under the 1" Rubber Ring.

3. It is possible that the fasteners (screws) that hold the motor gearbox together may have been over-tightened. Try loosening them up a 1/4 turn and see if this helps.

4. In rare instances, it may be necessary to place washers as spacers between the motor and mounting plate so as to relieve stress on the gearbox.
