N^o 141 SERVICE BULLETIN

SUBJ: T3™ Shooter Lane Switch Actuator Adjustment

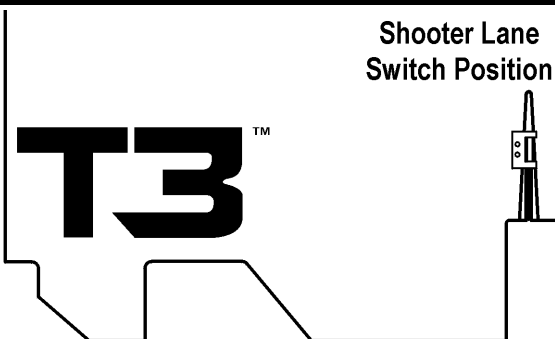
The **Shooter Lane Switch Actuator** is adjusted *too high*. This makes it possible for the Auto Launch Plunger to hit the switch actuator which causes a switch closure. The **CPU** then repeatedly energizes the coil every time it reads a *Shooter Lane Switch Closure*. *The coil then overheats and may damage the Q2 Drive Transistor.*

Adjust the switch actuator down so the Auto Launch Plunger fully extended (*use finger*) will clear the top of the actuator.
