Nº 149 SERVICE BULLETIN

SUBJ: Potential Ball Trap by the Upper Left Pop Bumper (ask your Distributor for SPI Kit Nr. 502-5025-81)

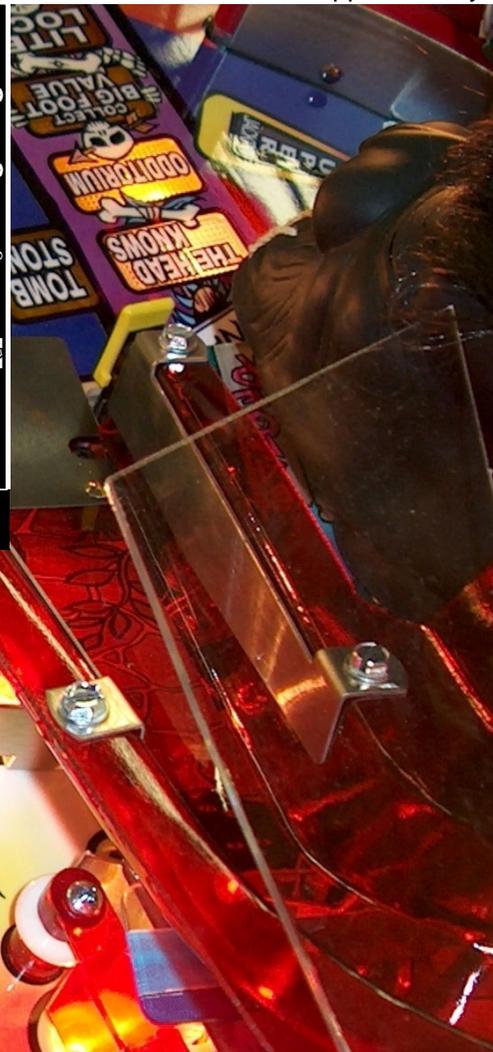
Figure 1

A Pinball gets trapped behind/under the **Upper Left Pop Bumper Cap** (next to Plastic Ramp). See Fig. 1 below.

Early production games had a Flat Rail, 535-9327-00 (Item 35, Page 64 of your Ripley's Service Game Manual) which did not extend out far enough to prevent a ball trap; if the extension measures approximately **3/8"**, **this fix is not required** (see Fig. C & D, next page). The next page depicts the old, modified and new rails so you can determine if your game requires this installation. **ONLY** Games with the extension measuring approximately **3/16"** would require this fix (see Fig. A, next page).

Get the Flat Rail (Ball Guide) Extension Installation SPI Kit, 502-5025-81 and install the Flat Rail (Ball Guide) Extension, 535-9468-00 (see Fig. B, next page). This kit includes a detailed step-by-step procedure with photos, a copy of this Service Bulletin and the new Add-On Extension Flat Rail and Securing Hardware.
